Extreme Networks Field Notice: 0016

MSM64i – Master/Slave Relationship at Boot Up

April 20, 2001

BlackDiamond MSM64i – PN: 50015

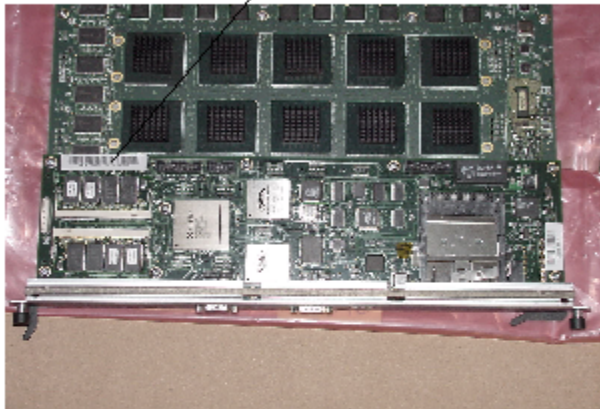
The difference in the two devices is noted by a change in part number on the daughter card of the MSM module. Refer to Figure 1 and 2 attached to verify the condition.

The faster MSM (AMI board) can be swapped into slot A. This should be done to verify and confirm that there is no operational problem with either MSM or the BlackDiamond chassis.

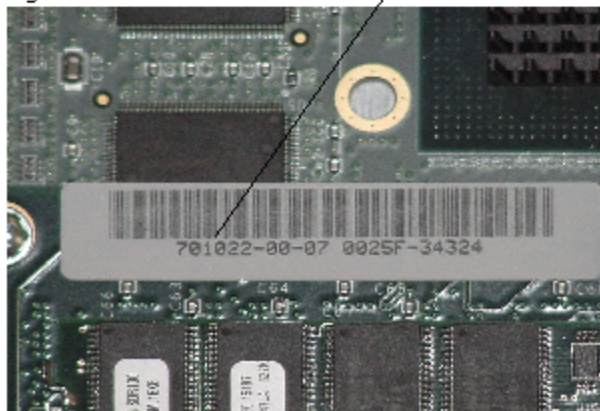
Figure 2 is up close picture of the bar coded label. The first 6 digits on the bar code label indicate the part number. In this example, 701022 is the part number of the daughter card. The part number of each device is as follows;

AMI ASIC (fast) - PN: 701025
Xilinx FPGA (slow) - PN: 701022
