ExtremeWare Release Notes

Software Version 4.1.20b3

Release Notes for ExtremeWare v4.1.19b2

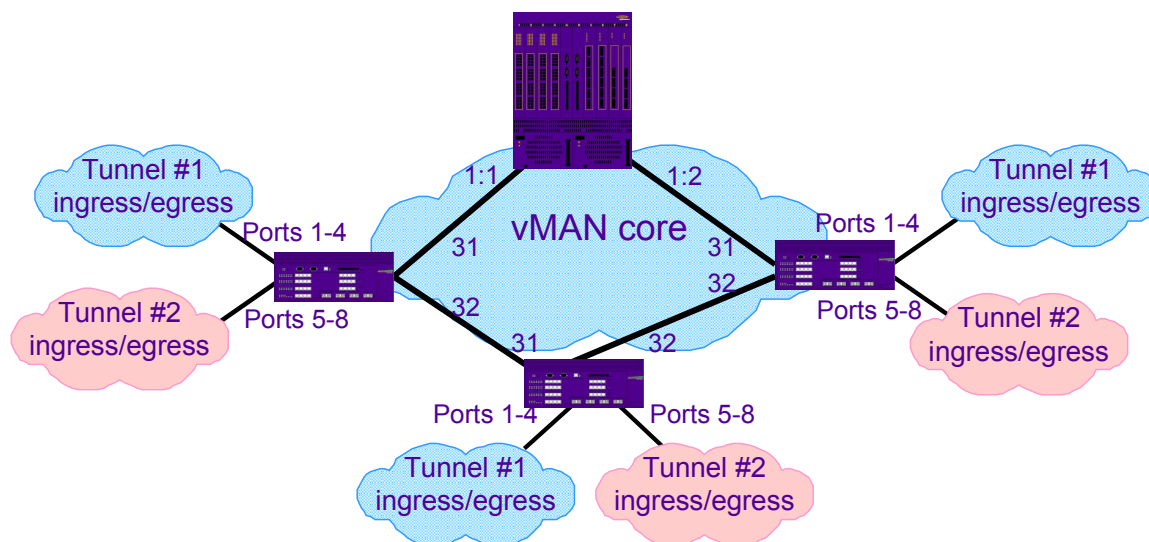
Depicted below is an example configuration with vMANs. Two tunnels are depicted that have ingress/egress ports on each switch.

- 1) modify the 802.1Q Ethertype the switch uses to recognize tagged frames
- 2) configure the switch to accept larger MTU size frames ("Jumbo" frames) and reboot the switch for the change to take effect (this command automatically updates all ports)
- 3) create tunnels by creating VLANs and configuring member ports as tagged on switch-to-switch ports and untagged on the tunnel's ingress/egress ports.

For all the switches that are shown, the configuration is:
