SANbox2

Firmware Release Notes

Version 1.5.1.04

50207-13 Rev A

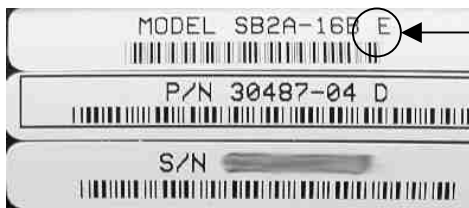
1. All SANbox2-16 switches with model numbers ending with the letters A through G (see below) cannot upgrade to the 1.4, or later, firmware release without contacting QLogic Technical Support first. Technical Support contact information can be found at the end of these release notes.

This letter will determine if a switch is capable of upgrading to 1.4, or later, firmware. This is located on the back of the SANbox2-16
